A COMPARATIVE STUDY OF THE EFFECTS OF APPLYING
ACRYLICS AND SILANES IN SEQUENCE AND IN MIXTURE,
WITH A CASE STUDY OF
THE COLUMN IN THE CONVENTO OF
MISSION SAN JOSÉ Y SAN MIGUEL DE AGUAYO, TEXAS

A THESIS

Historic Preservation

1994

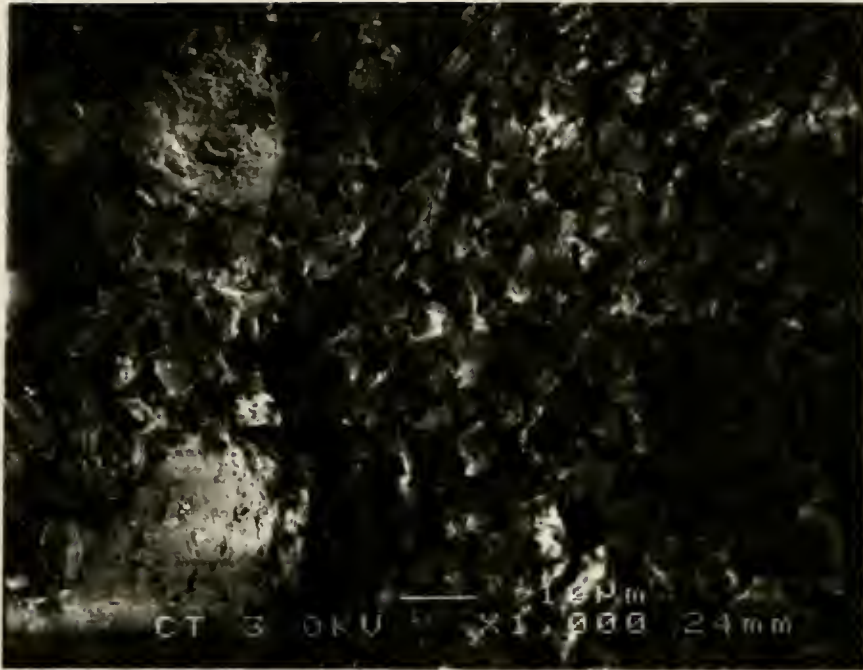
Figure 2.6 SEM photomicrograph of untreated and unetched facsimile (CT). Larger grains are quartz sand and smaller grains are marble dust (calcium carbonate). 3.0KV, 1000X magnification.

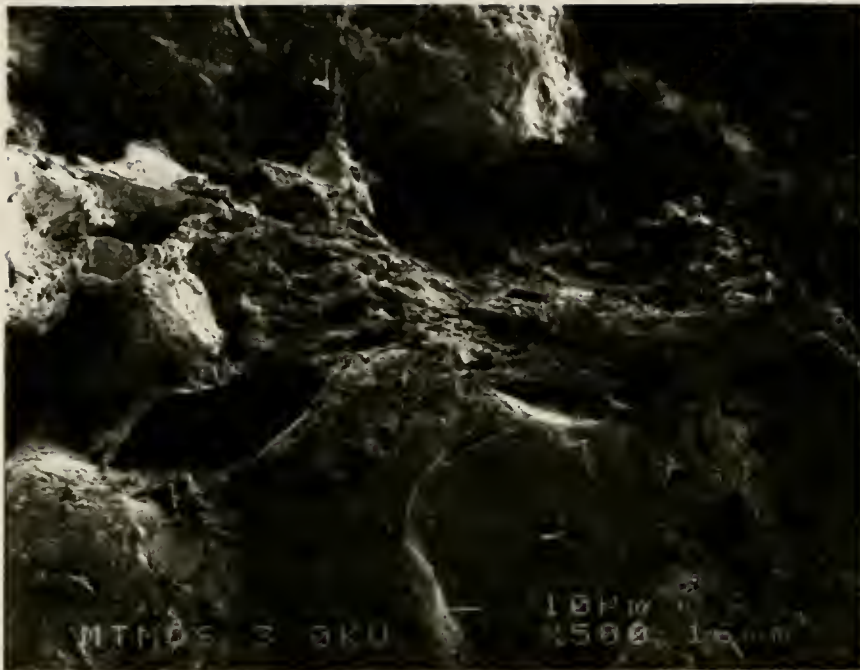
Figure 2.8 SEM photomicrograph of facsimile treated with an ethyl methacrylate/methyl acrylate copolymer (MMA) only and etched with 1M HCl. 3.0KV, 500X magnification.

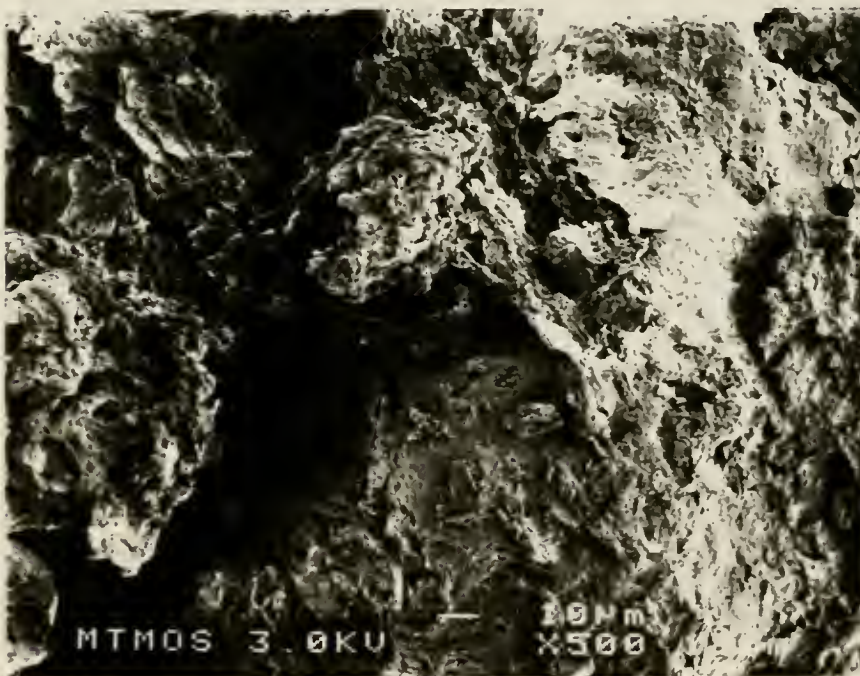
Figure 2.9 SEM photomicrograph of facsimile treated with methyl trimethoxysilane monomer (MTMOS) and etched with 1M HCl. 3.0KV, 500X magnification.

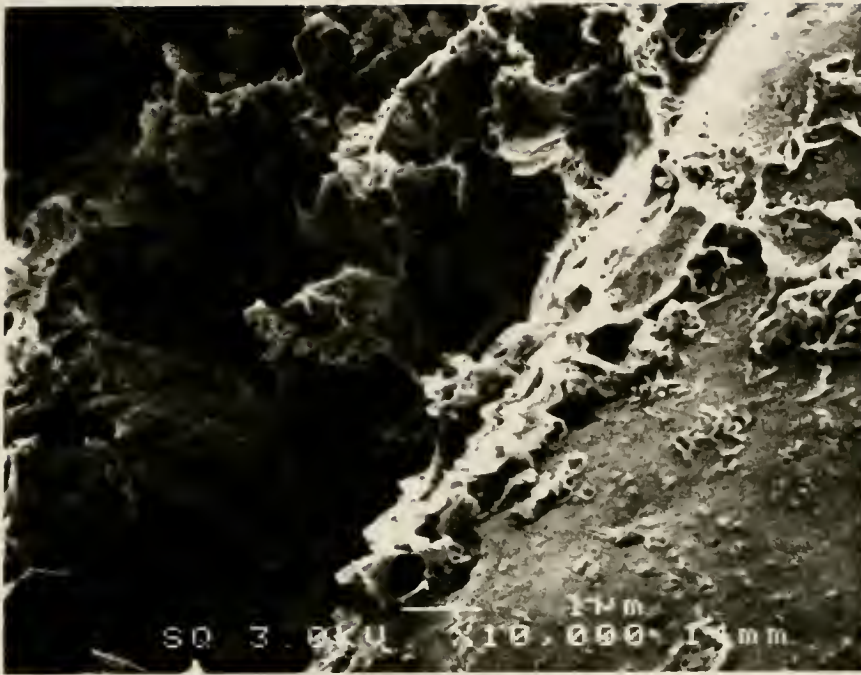
Figure 2.10c SEM photomicrograph of facsimile treated with OH followed by sequential applications of MMA and MTMOS (SQ) and etched with 1M HCl. 3.0KV, 10000X magnification.

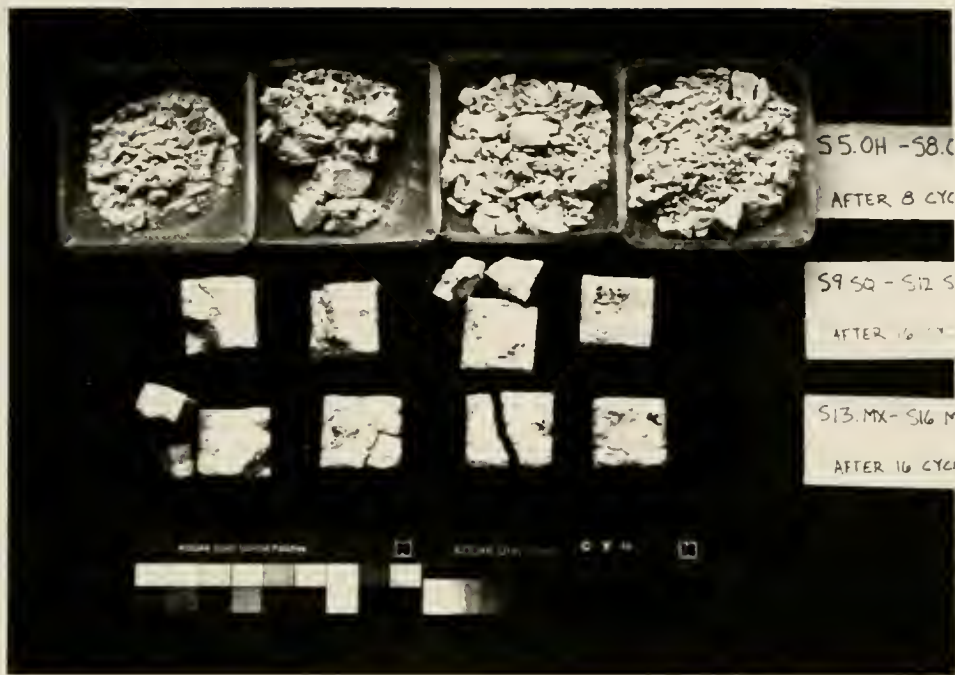
Figure 2.12 Appearance of facsimiles S5.OH - S8.OH after 8 cycles of salt crystallization, and appearance of facsimiles S9.SQ - S12.SQ and S13.MX - S16.MX after 16 cycles of salt crystallization.

As illustrated in Table 2.11, facsimiles treated only with OH were quickly destroyed by repeated immersions in the salt bath, although they displayed marked improvement over untreated CT facsimiles, which disintegrated upon contact with water. In contrast, the percent weight loss for groups treated with SQ and MX is very minimal through cycle 15, and the ultimate destruction of the facsimiles is much slower than that of the OH or CT samples (see Figure 2.12). In part, this may be a result of the consolidating properties of ethyl silicate (as observed in the improved resistance of the OH group over the CT group)

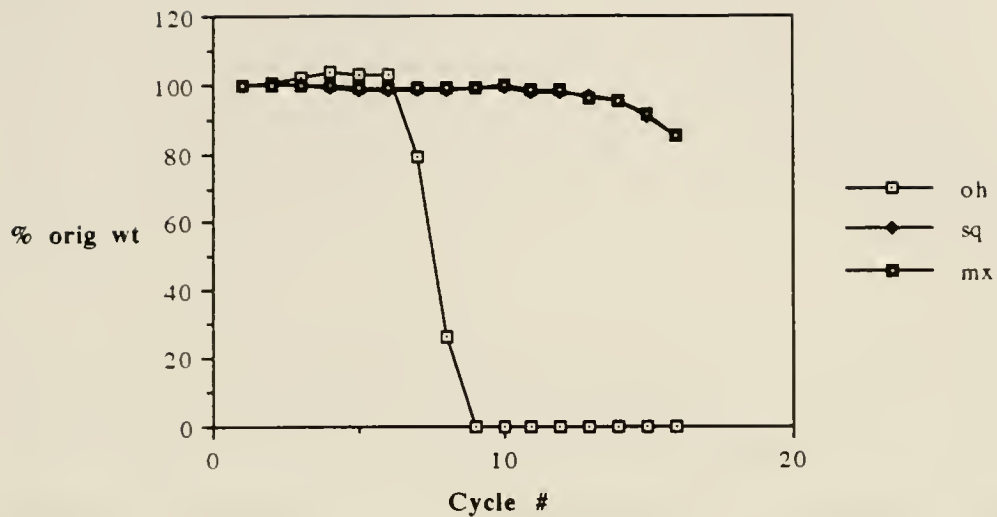
Figure 2.13a Resistance of treated facsimiles to salt crystallization, expressed as mean % of original weight. At this scale, data for SQ and MX samples nearly coincide.

which the different treatments deteriorated through repeated salt cycling (Figures 2.13a and 2.13b).

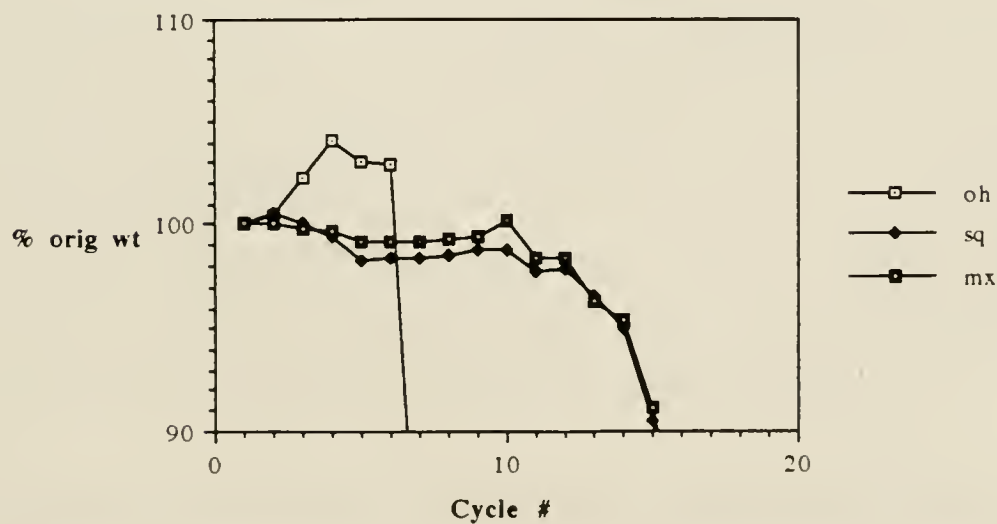
Figure 2.13b Detail, resistance of treated facsimiles to salt crystallization, expressed as mean % of original weight.

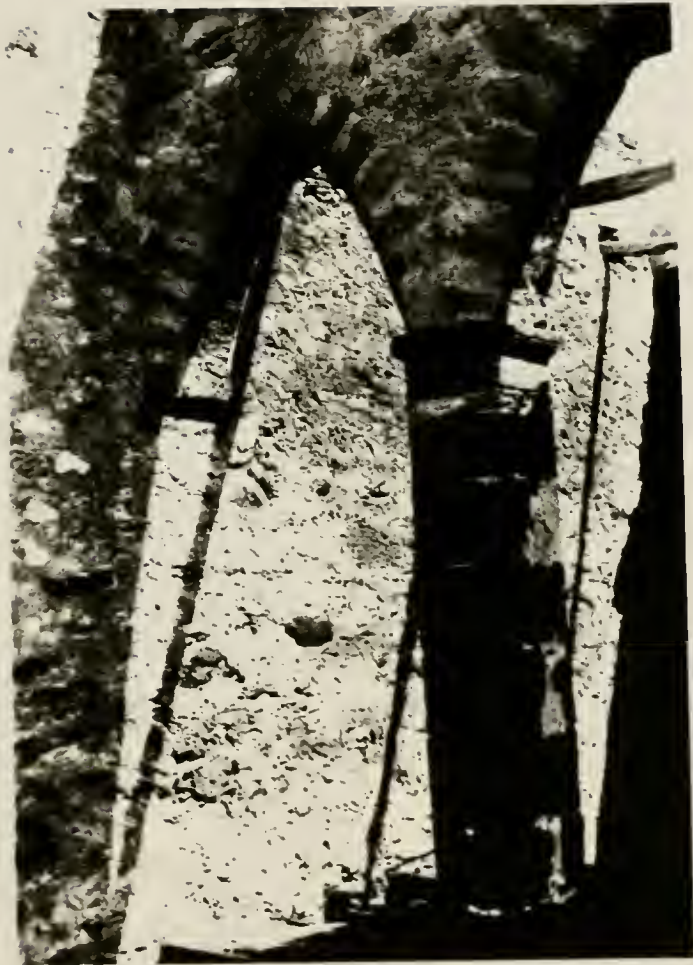
Figure 3.1 Southeast elevation of the convento column circa 1927 (courtesy Special Library, San Antonio Missions National Historical Park, San Antonio, Texas).

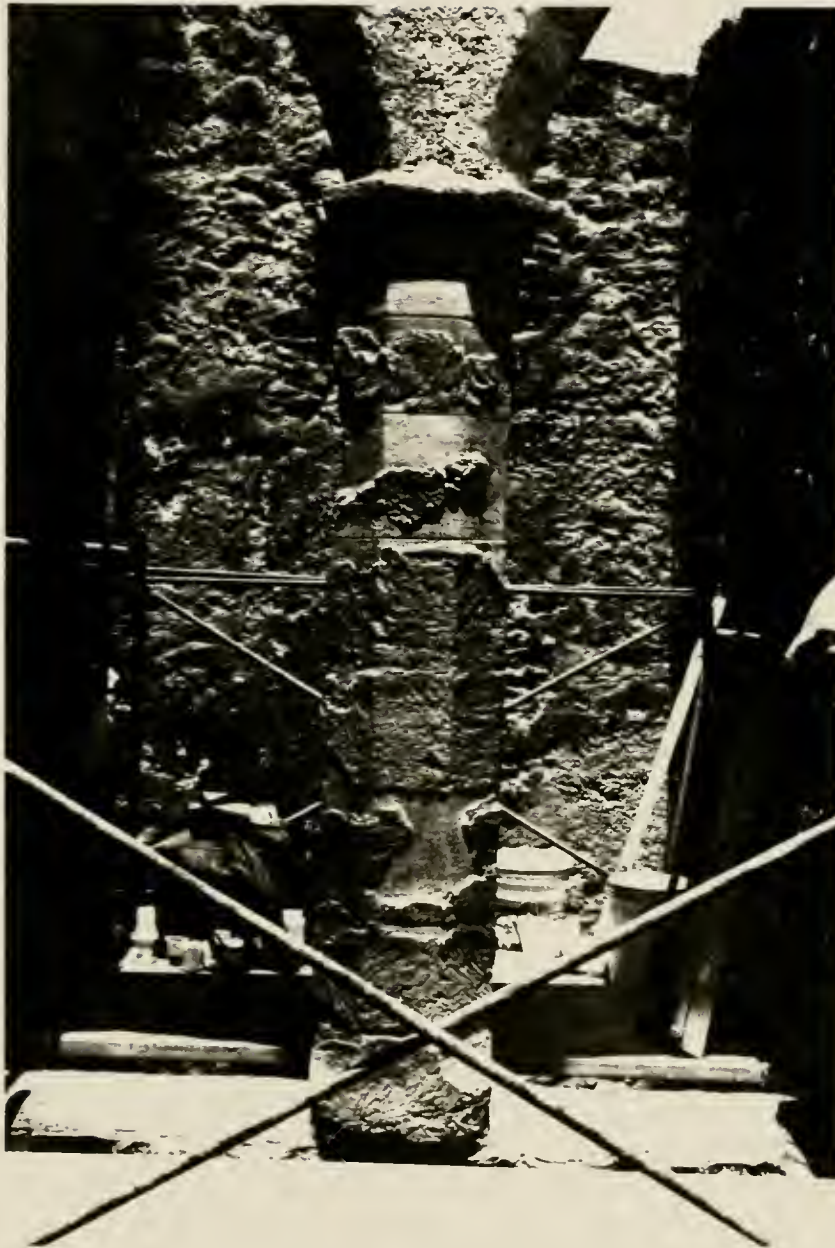
Figure 3.3 South elevation of the convento column after conservation, May 1993.

The conservation treatment of the convento column at Mission San José, using an ethyl silicate consolidant followed by sequential applications of methyl methacrylate and methyl trimethoxysilane, was successful. The use of the materials in sequential order allowed for flexibility in treating stone which exhibited only localized deterioration, and also permitted the subsequent application of infills. More time must elapse before the aging of the treatment can be evaluated, but after one year, no alteration or new deterioration was visible on either the stone or the infills of the column (Matero, personal communication).
